How to identify if your **SPYRE** brake needs to be replaced

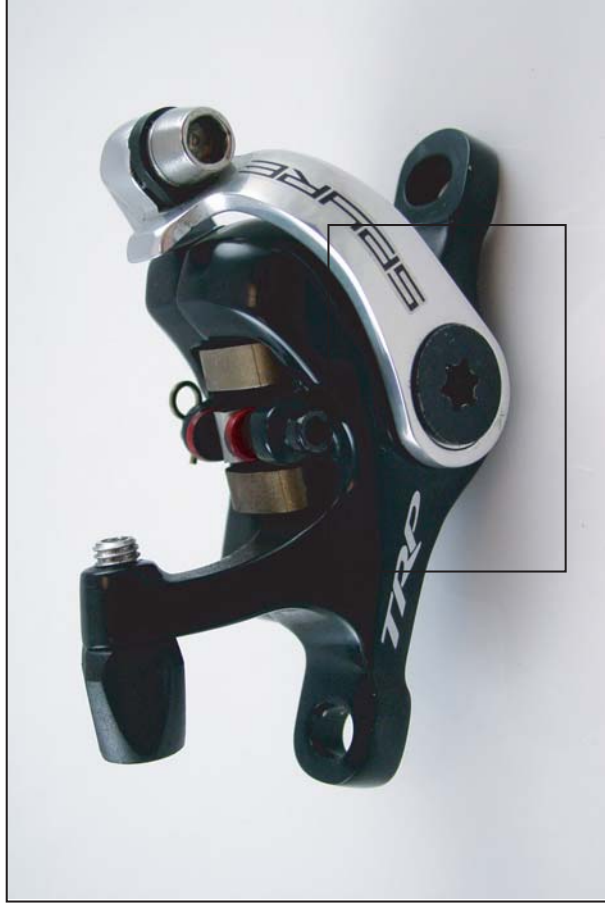
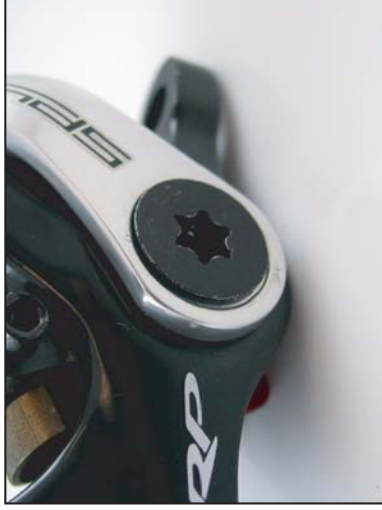
**Manufactured before December 6th, 2013**

The old Spyre had a single pad adjust screw and did not have laser etch markings. The outside is marked with a Torx head.

IF this is the case, please contact TRP Brake's Customer Service to arrange an exchange for a new caliper.

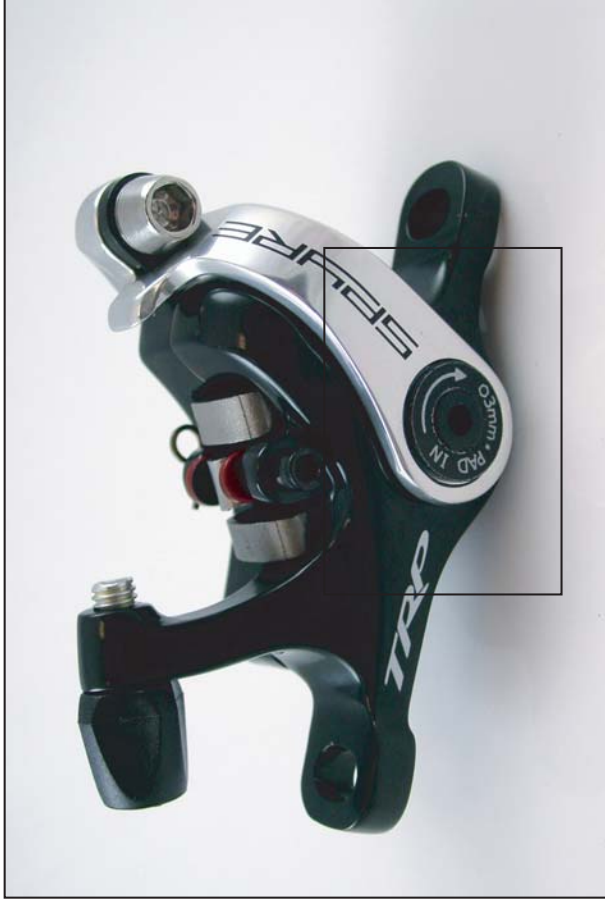
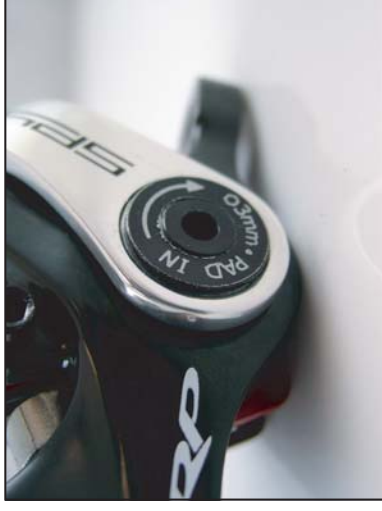
**Production after December 19th, 2013**

The new Spyre has a pad adjust on both sides of the brake. Using a 3mm hex wrench, the pad can be adjusted inward by turning clockwise.

If your brake appears as above, this unit is not affected by the recall.
