Bushing Pivot Adjustment

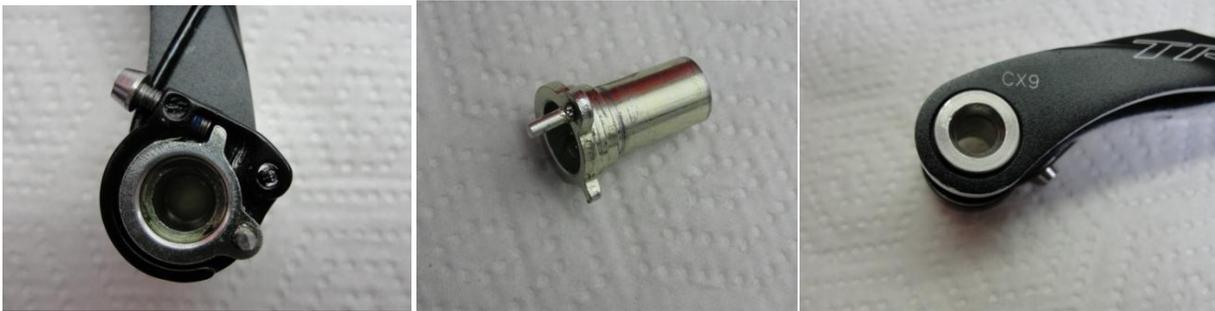
Sometimes the pivot action of the brake arm may be slow. This is either from dirt and grime build up in the bushing/pivot bushing, or a small irregularity/bulge in the leading edge of the bushing pivot itself. Fortunately, there is a straight forward and simple fix:

- Remove the bushing pivot assembly: Looking through the bushing from the back you'll see a small ridge at the front edge of the bushing pivot barrel. Simply take a small punch, lay it against the ridge and give it a SOFT tap until the top hat pops off and the bushing pivot barrel drops out
